# FARAD<sup>®</sup> made in Italy

Instruction manual

## KIT PR25 - 6

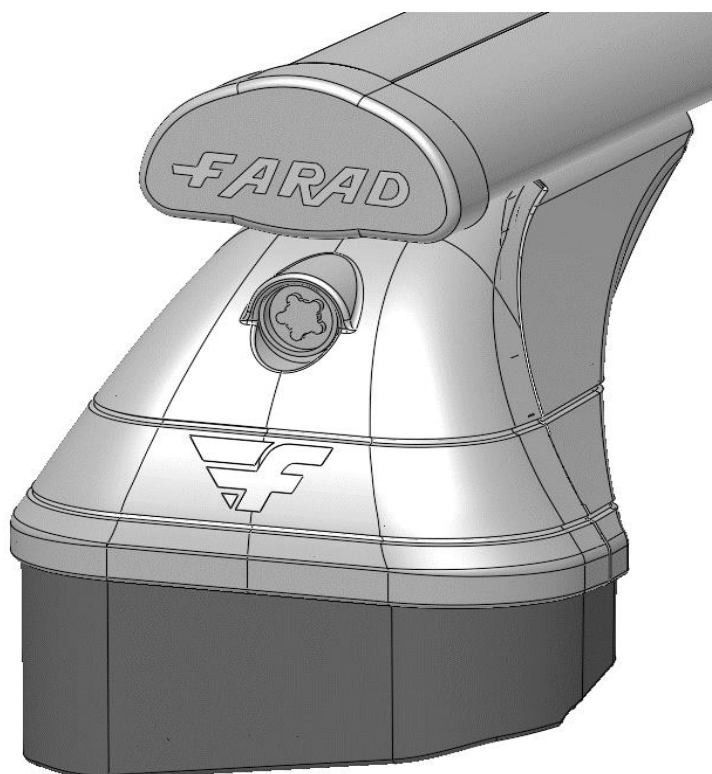
| A1 | | | G | | Nr. 4 |
| A2 | | COD. 91141/57 → Nr. 1+1 | H | | Nr. 4 |
| B | | COD. 91141/59 → Nr. 2 | I | | Nr. 4 |
| C | | → Nr. 4 | L | | Nr. 4 |
| D | | TCEI 8 x 18 → Nr. 4 | M | | Nr. 1 |
| E | | M8 → Nr. 8 | N | | Nr. 4 |
| F | | M8 → Nr. 4 | Y | | Nr. 4 |

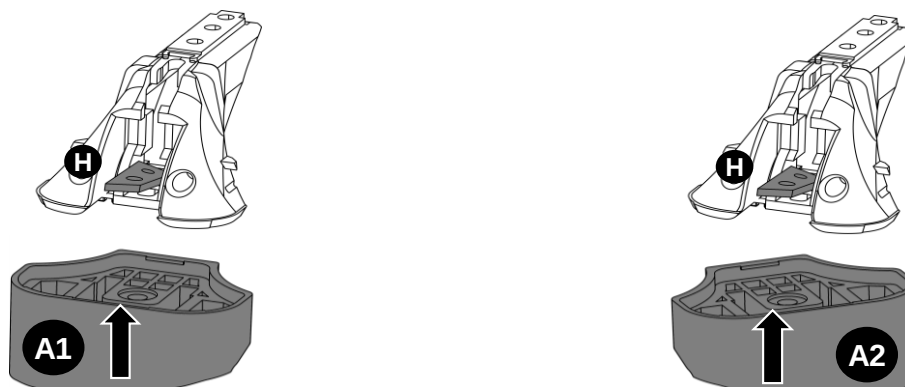
FRONT BAR

PR 25 ANT + 1

PR 25 ANT + 2

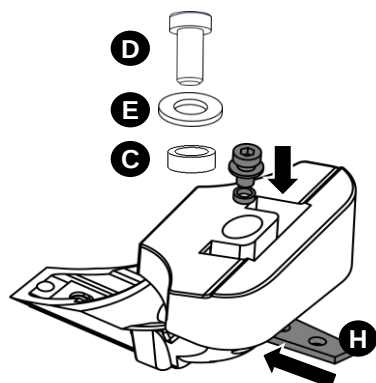
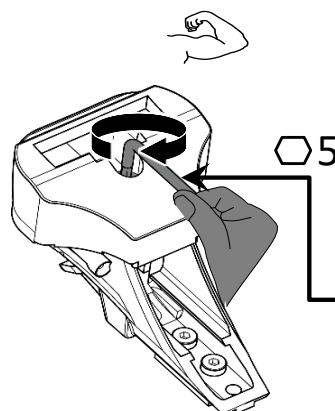
3

KIT LINK

OR

KIT COMPACT

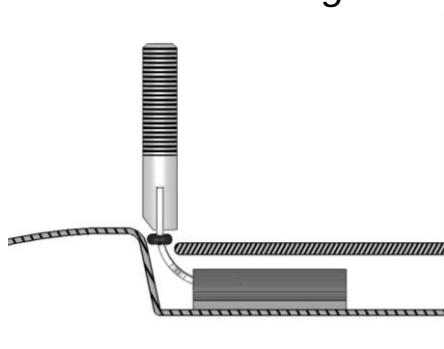
INSIDE RECIVER  
Correct fitting

**Make sure the clip is well engaged inside the metal receiver under the glass.**  
**Clip well fitted must not be able to move back and forth.**  
**Repeat this check controll at all 4 fix points**

**FAILURE OBSERVE THIS NOTE CAUSES GLASS BREAKAGE**

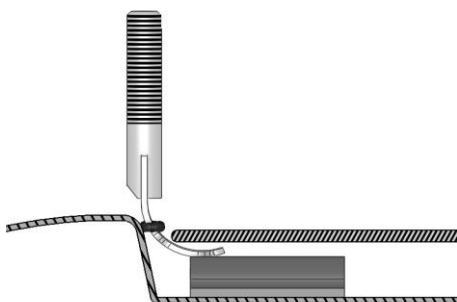
OUTSIDE RECIVER  
Wrong fitting
